Technical Report GL-95-5
May 1995

Geophysical Survey at Cluster 6, Westwood Area, U.S. Army Aberdeen Proving Ground

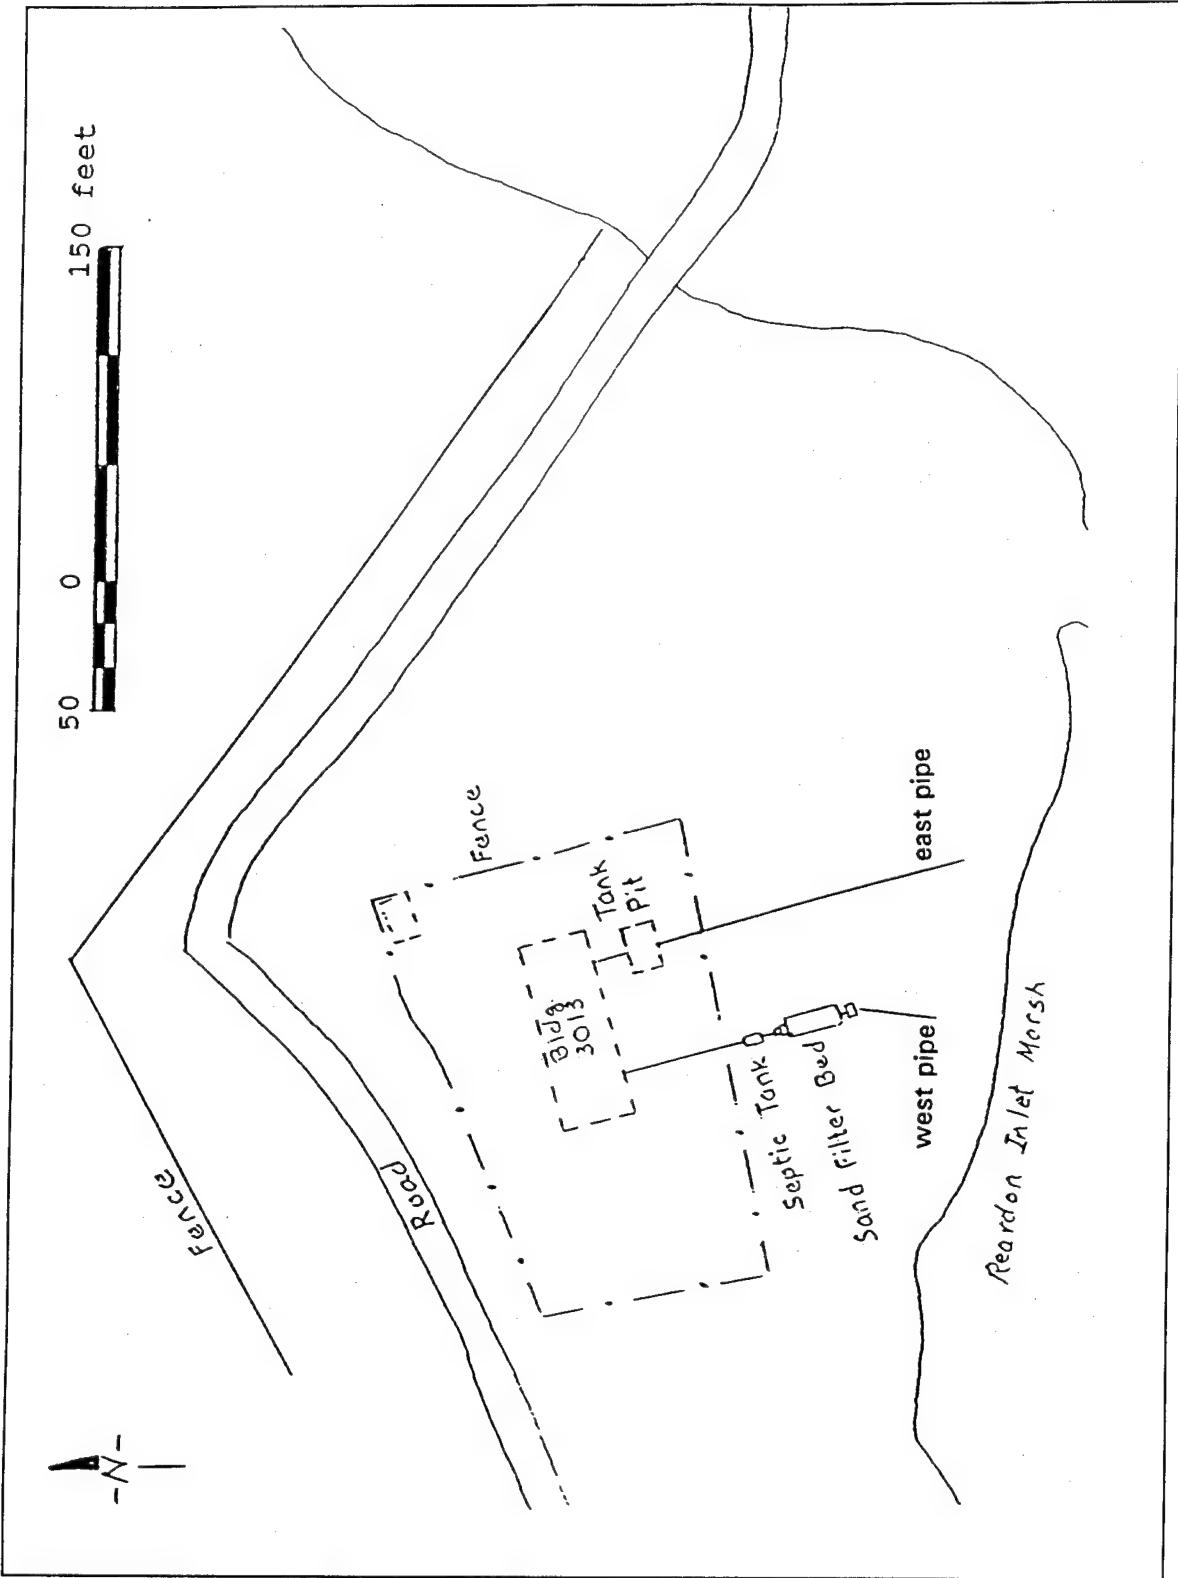
Figure 2. Site map showing probable location of structures and pipelines

A map of the site showing the probable location of former structures (denoted by dashed line) and the possible location of present wastewater lines and related structures (solid line) is given in Figure 2. Both pipes are visible at the outlet to Reardon Inlet Marsh. The east terra cotta pipe is at ground surface at the concrete outfall junction near the outlet and is exposed for five feet due north of the junction, where it is believed to continue underground (Figure 5). South of the concrete outfall junction is an exposed section of iron pipe. A washout gully runs along the same general line and direction as the terra cotta pipe, and it is suspected that the pipe either underlies or parallels the gully.

The west pipe is known to extend 12 ft due north of the exposed end at the outlet to Reardon Inlet Marsh. Beyond that point it is not sure if the pipe continues in the same direction or makes a turn, as indicated in Figure 2. A strong magnetic anomaly detected due north of the exposed pipe end during the reconnaissance survey, indicating the possible location of the septic tank, suggests that the pipe probably does not angle off in another direction, but extends due north to the anomaly. Figure 5 shows the known locations of both pipes and the survey grids.

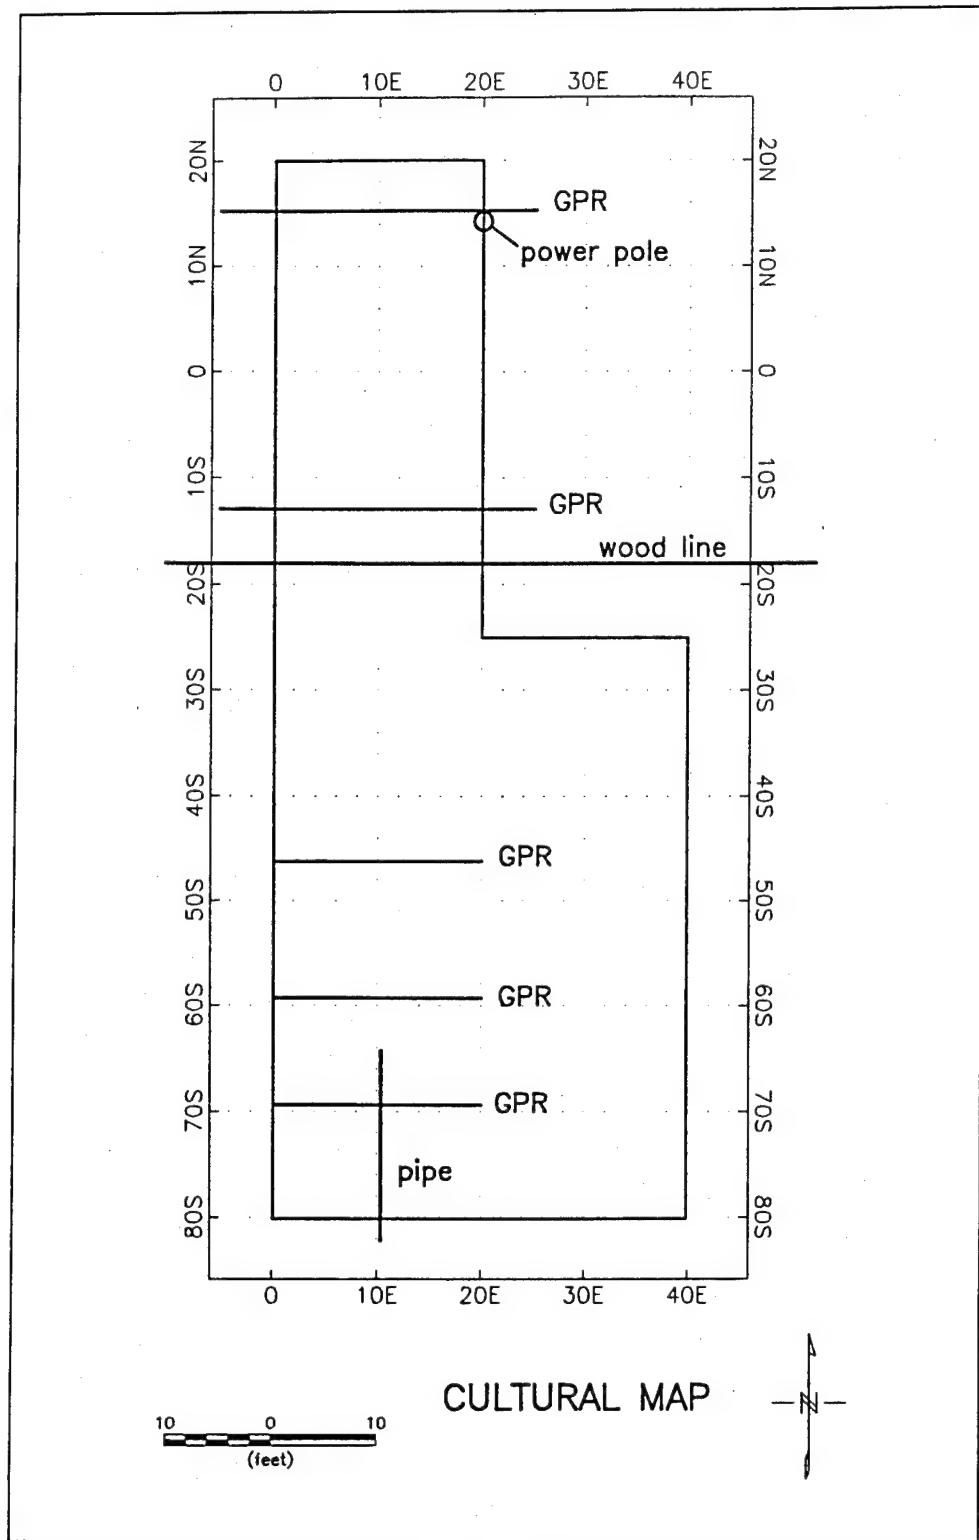
Figure 6. Cultural map of west survey grid

The west pipe area was surveyed to determine the location of the terra cotta pipe and associated septic tank and sand filter bed. Figure 6 depicts the survey grid with surface and cultural features noted. The magnetic and EM-38 inphase surveys were performed over a portion of the grid extending from (0E-20E, 40S-20N). The primary purpose of these surveys was to locate the septic tank. The EM-38 conductivity data were initially collected over the same area, however the grid was extended (to 40E, 80S) to encompass an anomalous region.

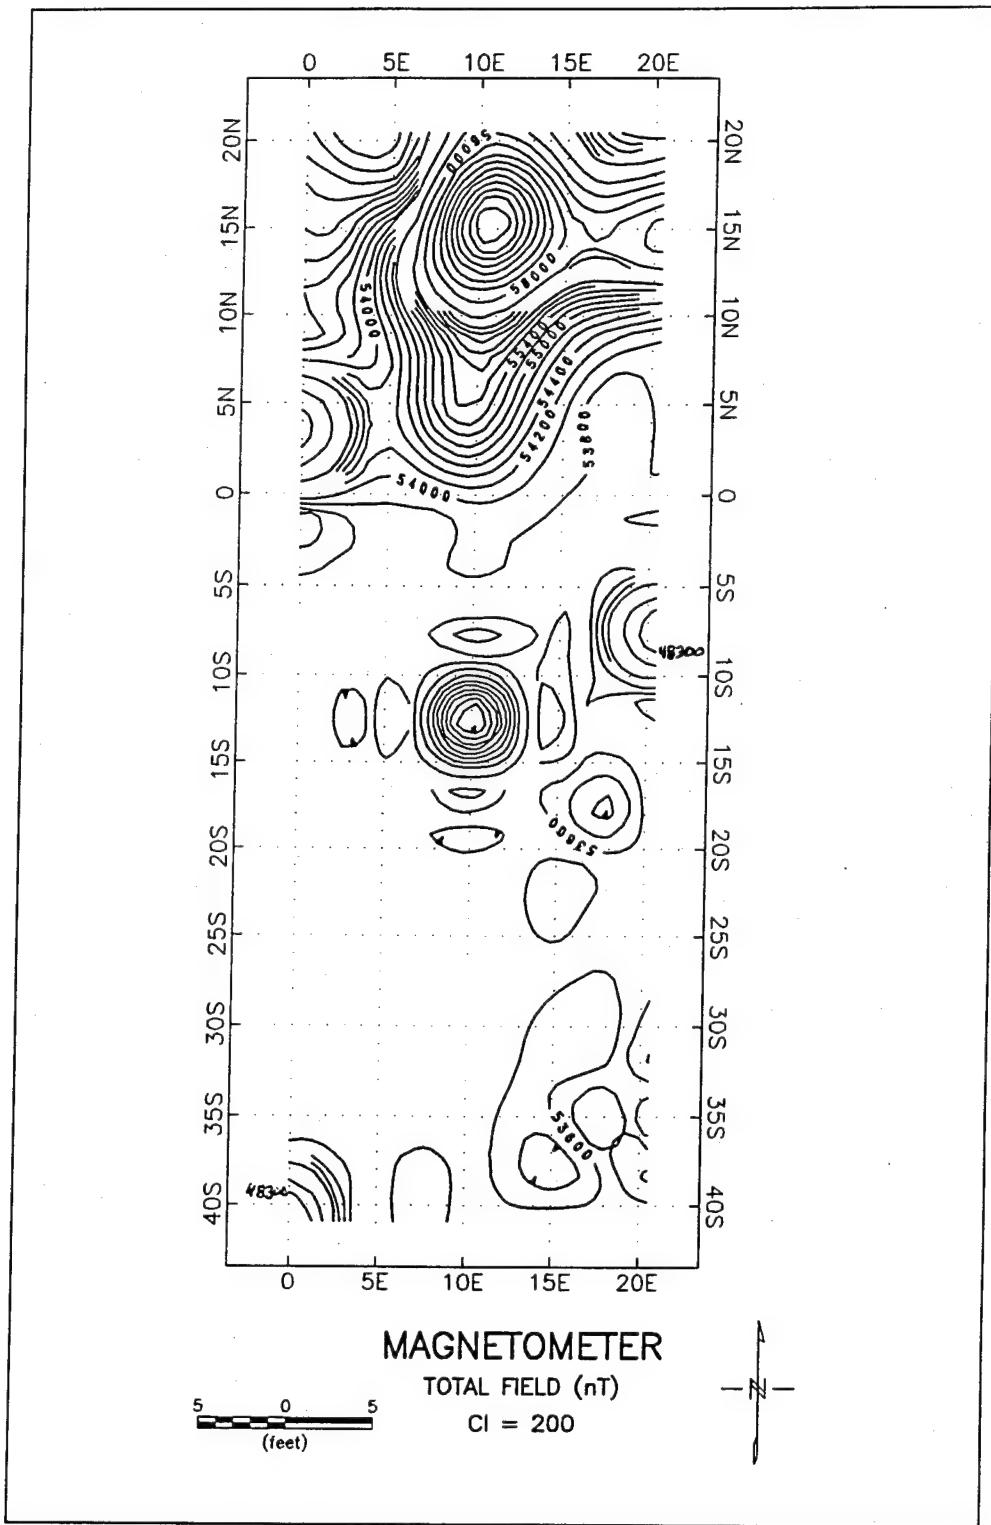
The magnetic total field data are presented in Figure 7. The large high anomaly centered at (10E, 15N) and at an estimated depth of 3.5 ft is the suspected location of the septic tank. The high extending from the anomaly to 20E is probably due to a cable which terminates about one foot above the base of the telephone pole located at (20E, 14N). The magnetic high also exhibits

a southward trend, suggesting the location of a ferrous metallic pipe fitting on the outside of the septic tank. The magnetic high at (0E, 4N) and lows at (0E, 40S), (10E, 13S), and (20E, 7S) are due to small, shallow, ferrous objects. It is possible that the anomaly low at (10E, 13S) may be associated with the wastewater system since it is in line with the suspected location of the pipe.

Figure 7. Contour map of magnetic total field data for a section of the west survey grid

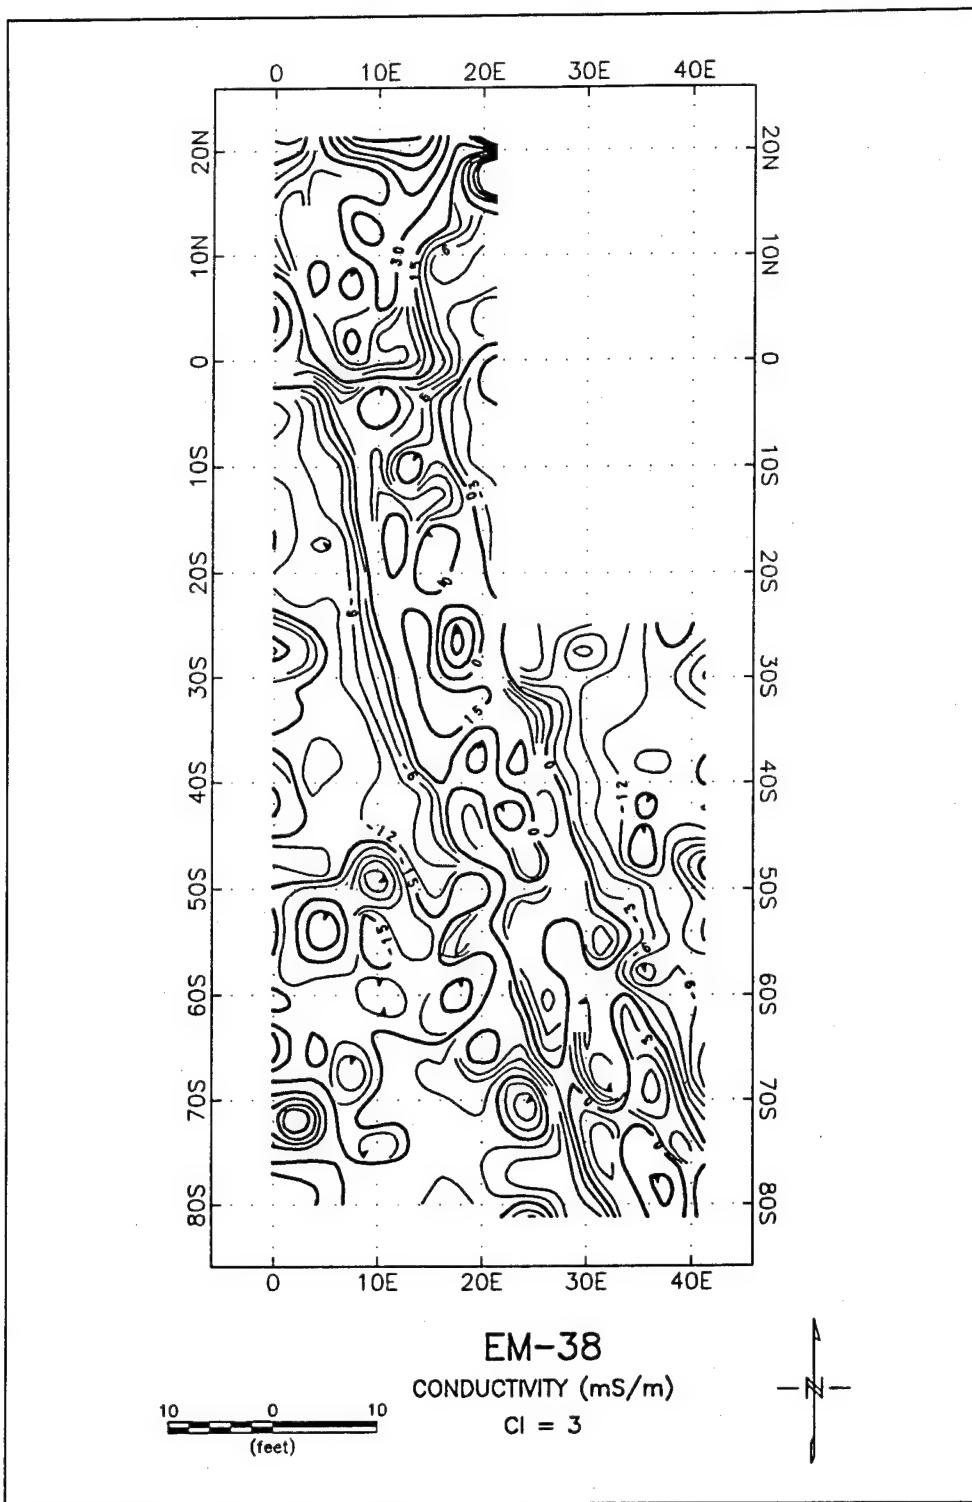
A plot of the EM-38 conductivity data is given in Figure 8. A strong conductivity high is located between (0E-15E, 0N-20E), the same area where the magnetic high is located. There is also a linear conductivity high trending to the southeast toward Reardon Inlet Marsh (5-15E, 2S to 32-40E, 80S). This anomaly may represent a trench filled with a higher conductivity soil than that of the local soil, or it may indicate a drainage path where the soil is more saturated than the surrounding material. It is doubtful that this linear anomaly is related to the terra cotta pipe since the exposed pipe is located 30 ft west of the southeast end of the linear anomaly high. The high at (2E, 72S) is due to a small, shallow object.

Figure 8. Contour map of conductivity data for the west survey grid

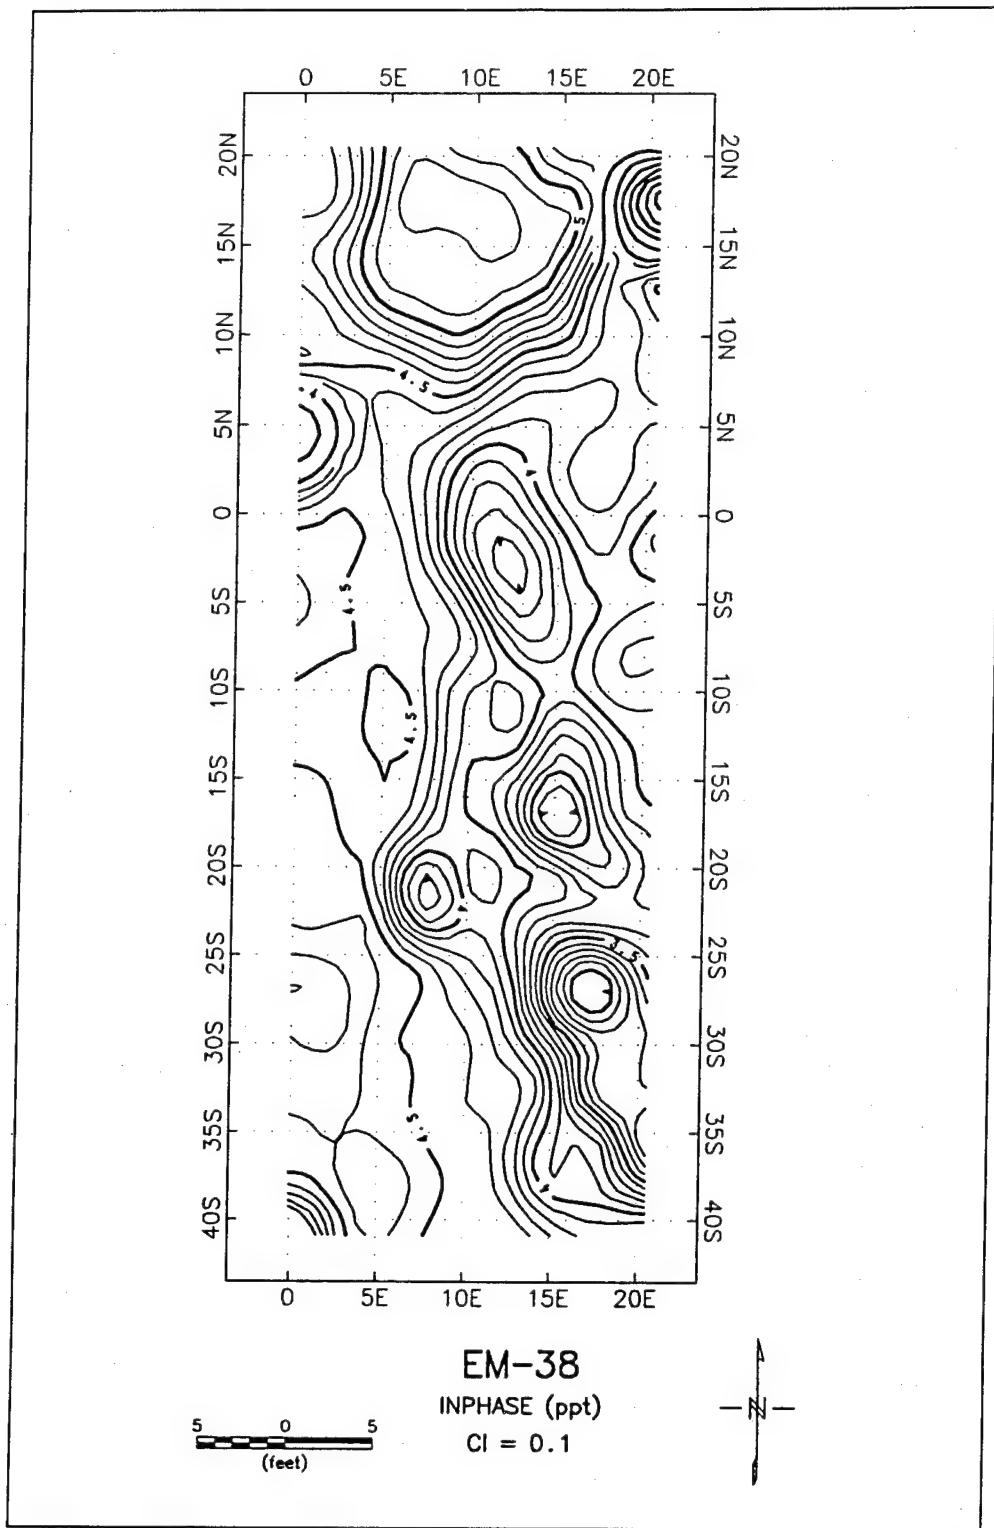
The EM-38 inphase data indicate an anomaly high at the suspected location of the septic tank (5E-15E, 10N-20N) (Figure 9). A linear anomaly low that corresponds to the linear conductivity high is also seen, indicating the presence of a material which differs from that of the surrounding soil.

Figure 9. Contour map of inphase data for a section of the west survey grid

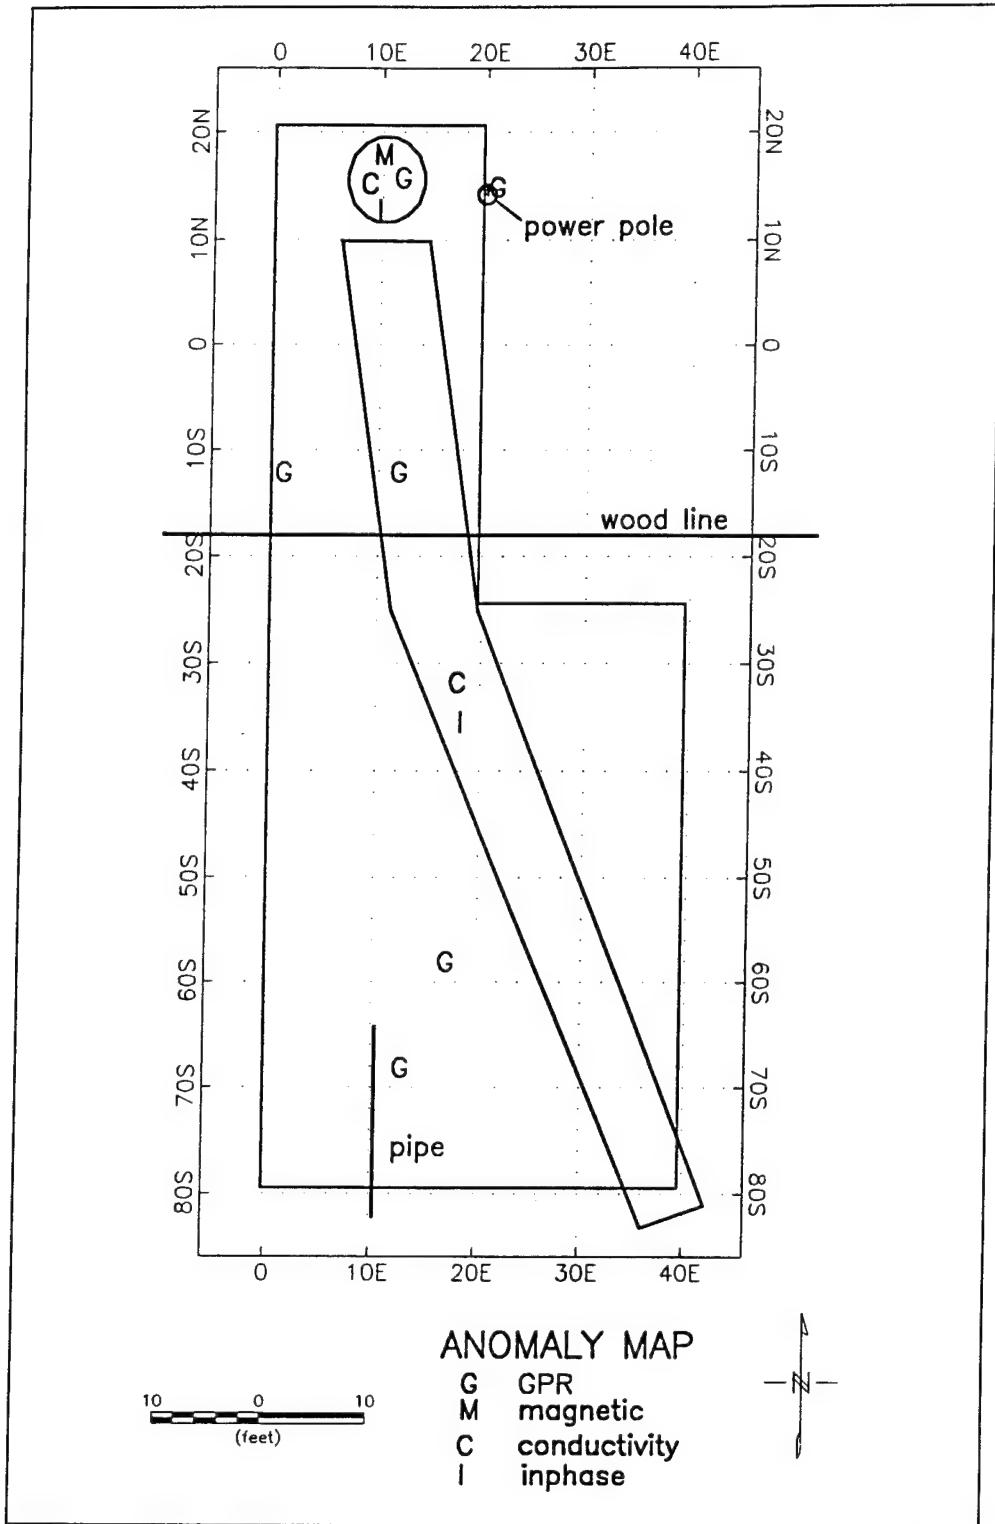
Figure 15 shows the location of the major anomalies detected on the west grid by the various geophysical methods.

The magnetic and conductivity surveys identified a large high associated with the western pipe system which is thought to be due to the septic tank. The center of the high is located 97 feet due north of the exposed end of the pipe at an estimated depth of 2-3.5 ft. Neither data set gave any indication of the location of the terra cotta pipe. Of the four GPR lines which traversed the suspected location of the western pipe, two showed anomalies at locations where the pipe is believed to be buried. No method utilized was able to determine the location of the sand filter bed. A southeast trending linear conductivity high which extends from the suspected septic tank to Reardon Inlet Marsh was detected. The anomaly may represent a trench filled with a higher conductivity material, or it may indicate a drainage path where the soil has a higher degree of saturation than that of the surrounding soil. Further investigation of this anomaly is warranted.

Figure 15. Plot showing location of main anomalies detected on west grid

Since the location of the terra cotta pipes could not be positively determined, it is recommended that a metal rod, approximately 3 to 4 ft long, be used to probe the subsurface to determine the exact location of the pipes.

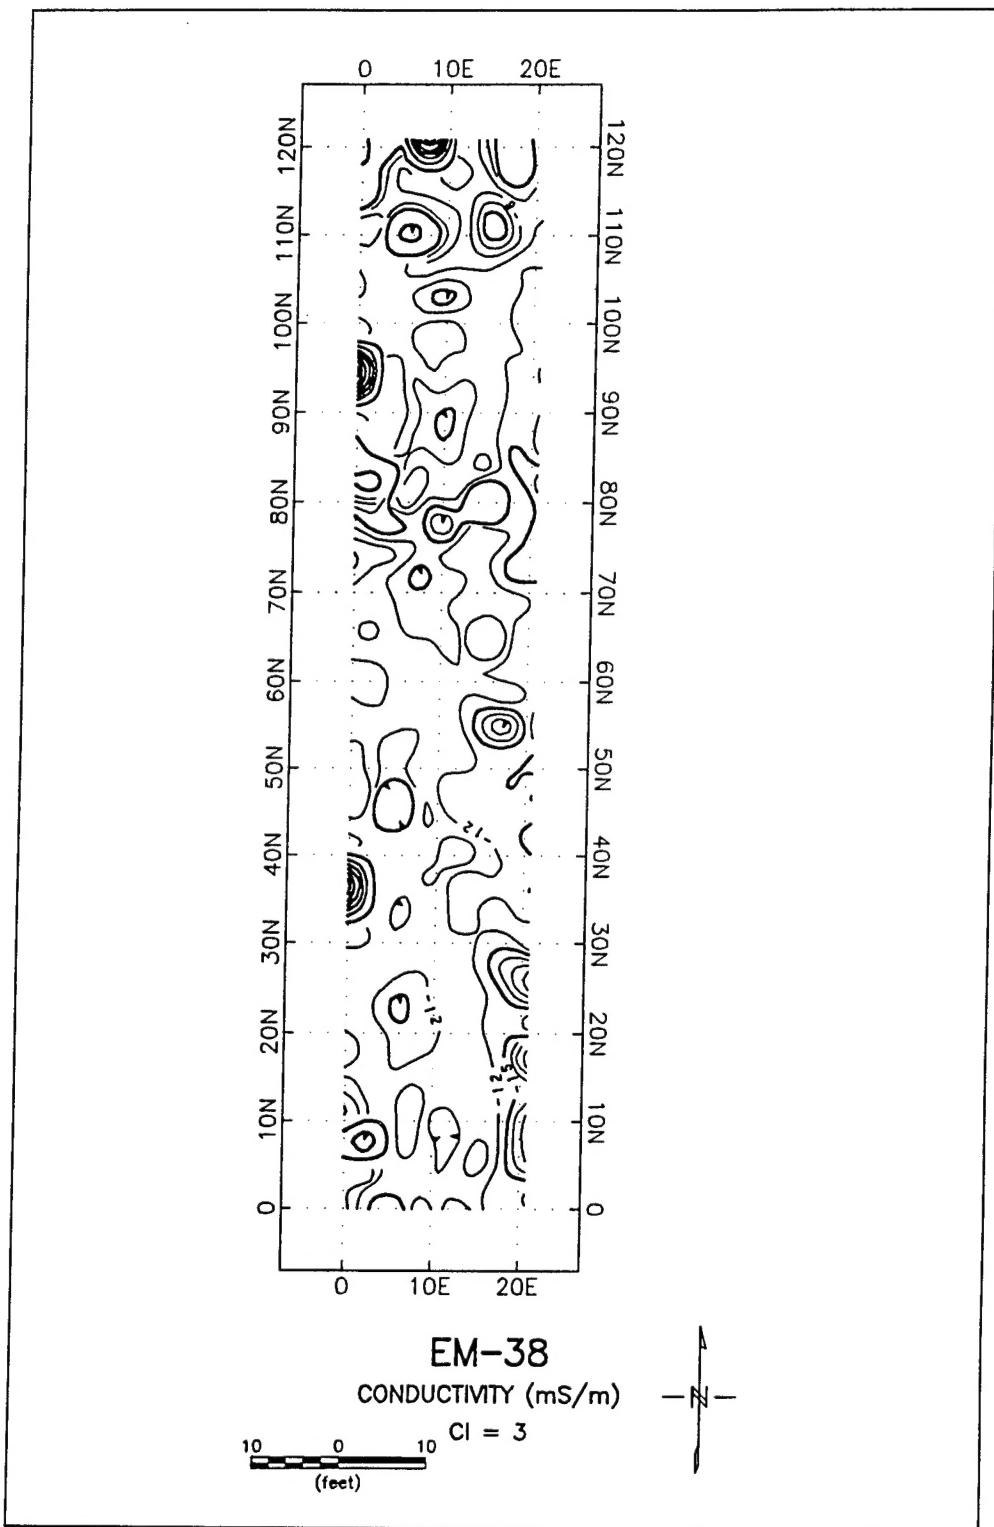
The EM-38 conductivity data are presented in Figure 17. The data do not exhibit any linear trends which would suggest the location of the pipe. A very small anomaly high due to an unknown shallow object is located at (15E, 112N).

Figure 17. Contour map of conductivity data for east survey grid

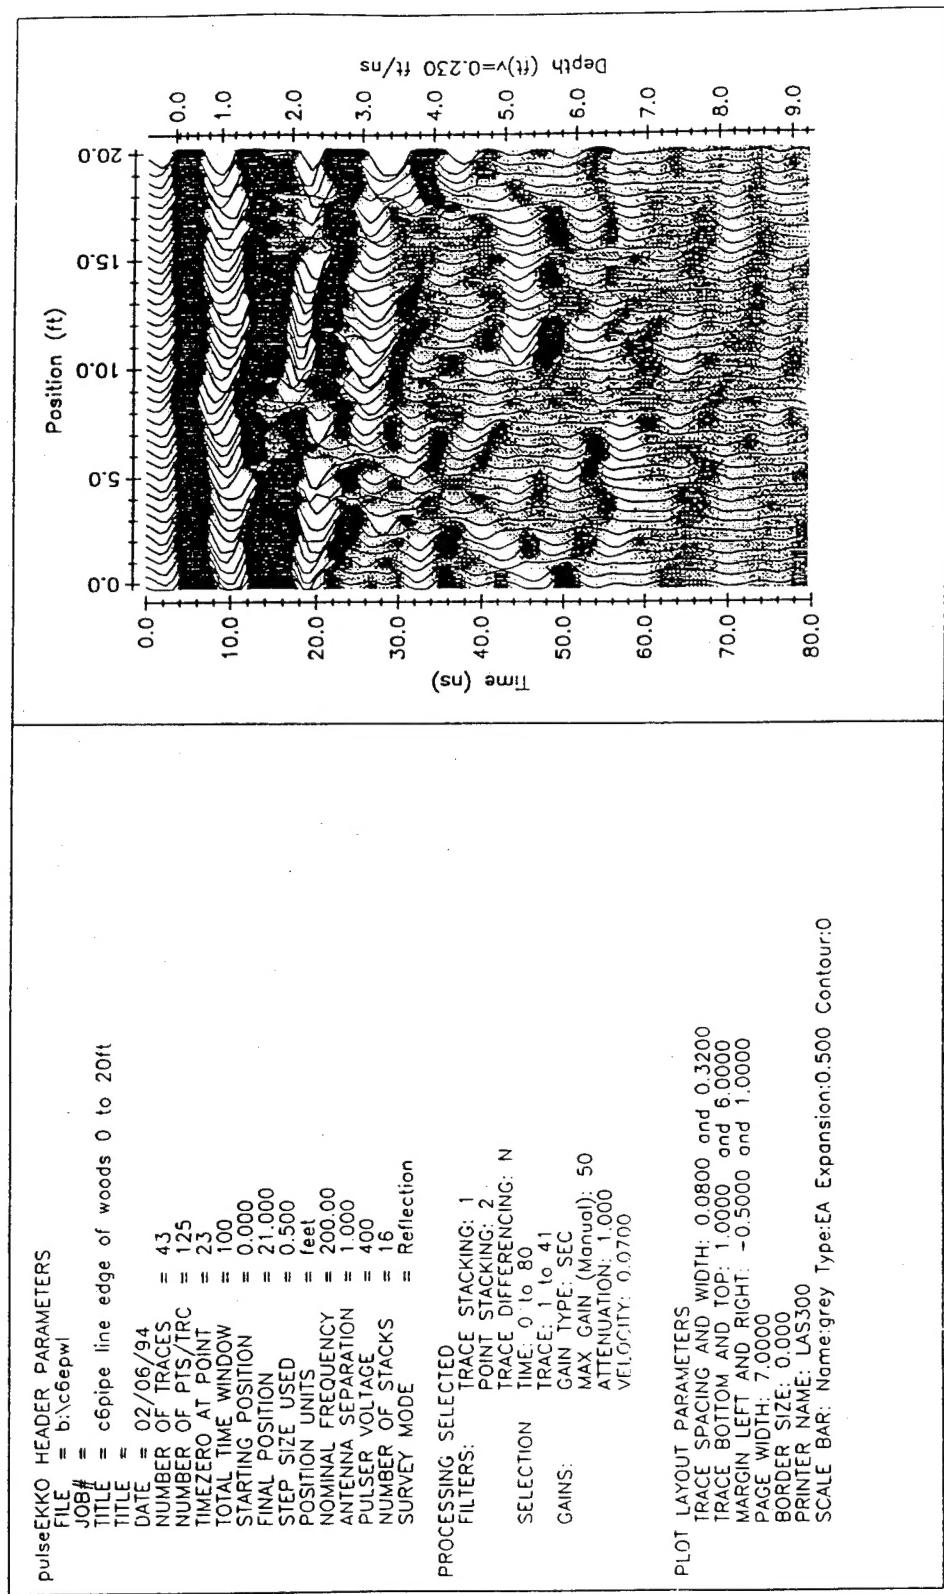
A plot of the GPR profile data is given in Figure 18. There are no obvious anomalies in this data. One point (7.5E, depth 1.8ft) is suspicious, but it may be where the 1.3 ft deep subsurface layer is splitting into two layers.

Figure 18. GPR profile line 107N on east survey grid
